HEAT EXCHANGER CLEANING

Date: March 2024

Location: Offshore Asset, Irish Sea

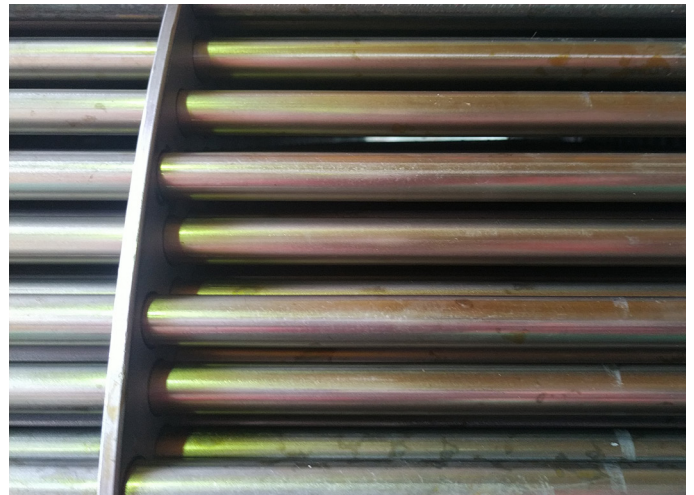
Photo: After cleaning

A 3-man multi-discipline team was mobilised to execute this scope of work. Through use of bespoke jetting techniques, the team cleared the tube bundles and shell of scale and debris to allow for an Internal Rotary Inspection System (IRIS) inspection to take place.

Conventional retro-jetting didn't provide the desired end result. Therefore, Stork's team of experts re-assessed the scope and altered the methodology to tackle the challenge. This ultimately ensured our client's expectations were met. The deployment of specially selected jets were utilised to remove the hard scale. A jet centraliser was used to protect the jet as it passed through the vessel internal shell, centralising the jet extension arms to a stand-off distance for a more consistent clean.
